EVALUATION OF 30 KW AND 2.5 KW  
GENERATORS USED ON SERVPAC  
ARS AND ATF CLASS SHIPS

November 1974

Prepared for  
PERA(CSS)  
Hunters Point Naval Shipyard  
San Francisco, Calif.

Publication 1620-01-2-1338

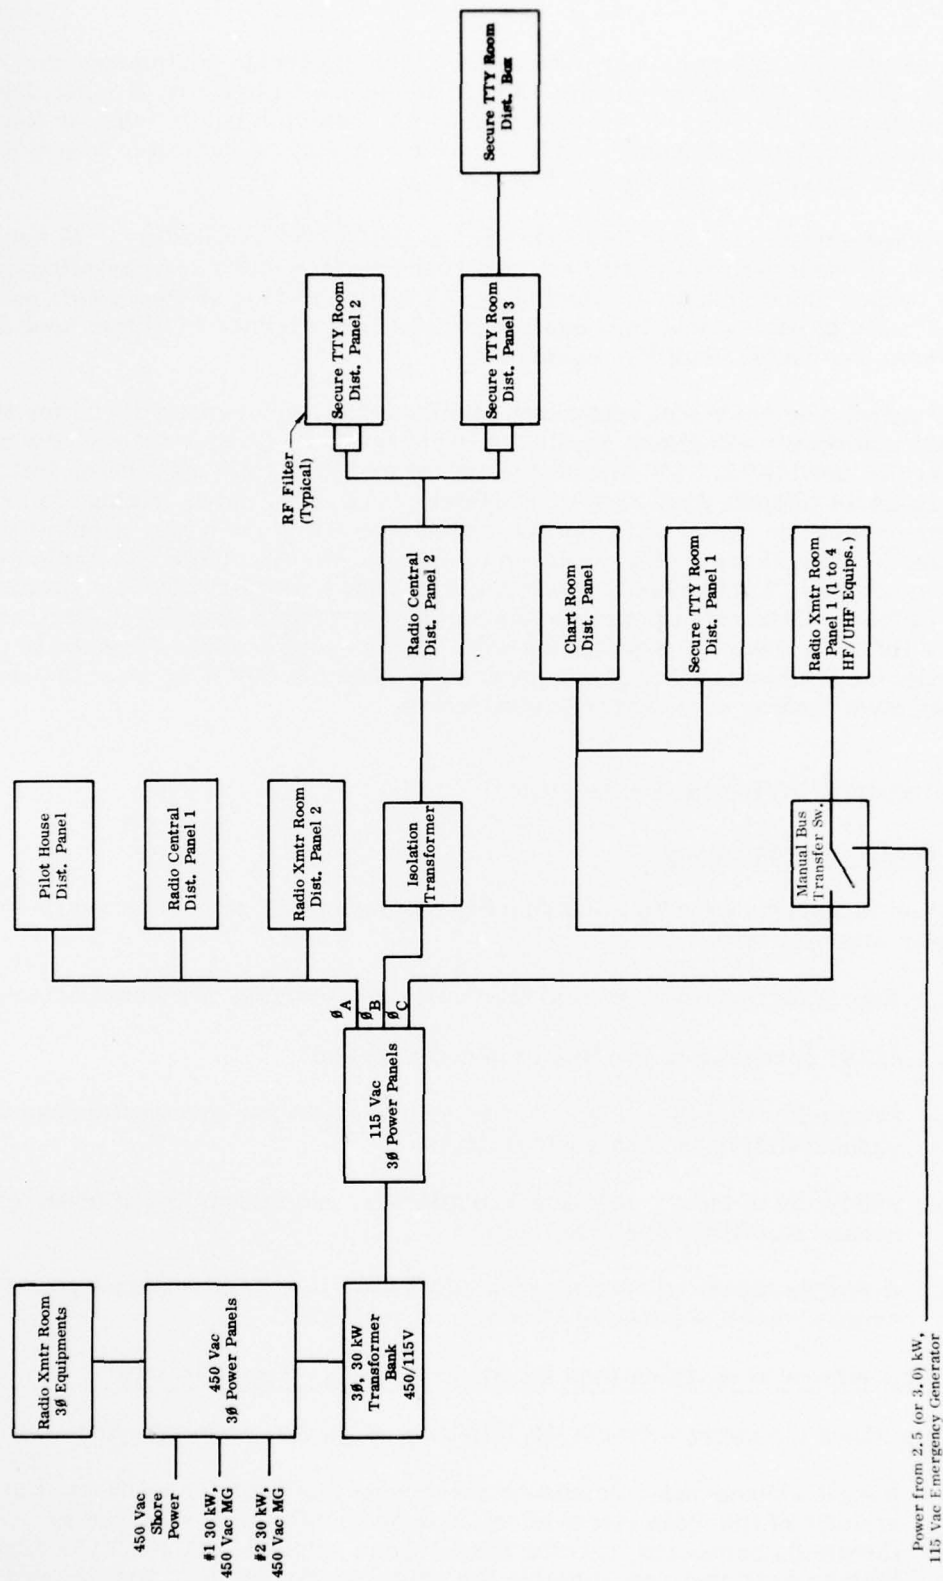
Figure 2. Typical Electronic Equipment Power Distribution

equipments in the transmitter room (see Figure 2). Figure 2 exemplifies the situation where the emergency diesel generator can be connected only to the radio transmission room, a common situation among the subject ship types.
